1003 Weldin Circle Weldin Woods

SELLER'S DISCLOSURE OF REAL PROPERTY CONDITION REPORT

1003 Weldin Circle Photographs

STRUCTURES UNLIMITED, LLC

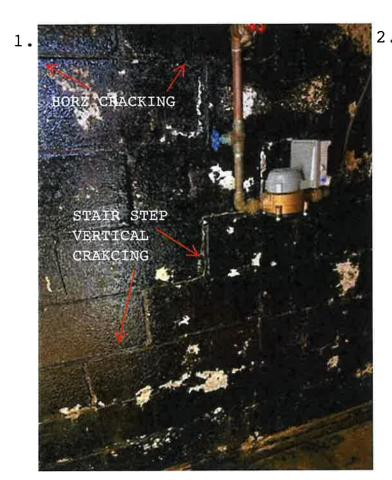
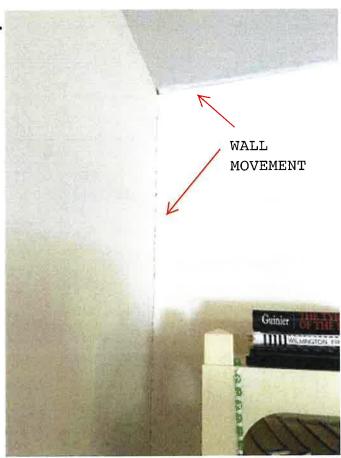
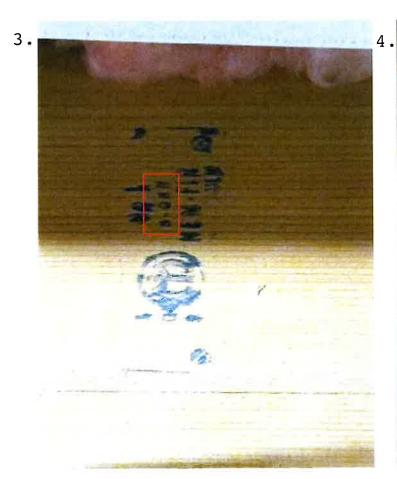
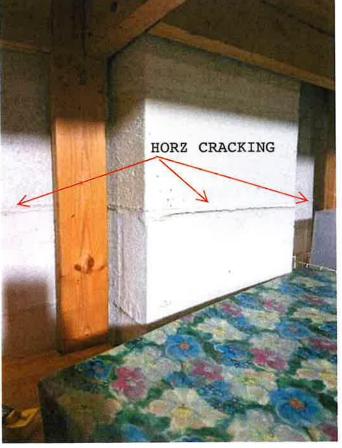
There is horizontal cracking that has occurred in the front wall. A horizontal crack is occurring along the 4th courses down from the top along the front wall of concern. See photograph #4. The crack is approximately 1/8th of an inch wide. Steps will need to be taken to strengthen and repair this rear foundation wall.

Along the right-side of the front foundation wall is a stair-step vertical crack. The wall appears to have a black waterproof coating. See photograph #1. The stair step crack has connected with a horizontal crack. Some internal re-bar will be required to 'sew' the masonry units together along with strengthening the wall due to horizontal cracking.

The hardwood floors have rolls and dips. This is common for floors that are framed with green lumber. A corner wall has noticeable separation and has dropped. See photograph #2. I was not able to connect this movement with a structural issue but most likely defined as a chronic crack area.

Problem Assessment: Unfortunately, the basement foundation walls were not initially built to code. The maximum unbalance height of fill against such a foundation wall that was allowed by code and standard practices back when this house was built was 4 feet (and still is). The backfill height in this situation is in the area of 7'-0" or more along the front.

By analysis (see attached), the maximum tensile stress that's developed in the wall under the aforementioned conditions is in the order of 138 pounds per square inch (psi) while the allowable stress for the concrete masonry construction involved is only 23 psi.

As shown in the calculations attached, the wall was initially beyond its limitations and with the additional lateral forces from expansion of the clay in the soil and higher hydrostatic pressure, and weight of the concrete porch slab the wall simply buckled from the force. Provisions will need to be taken to counter act the tendency for the basement wall to further move laterally inward and possibly collapse.

The vertical cracks in the cmu foundation wall are classic signs of differential settlement. These types of cracks are quite common for foundation walls that are situated above expansive clays. Furthermore, foundation walls lose continuity at openings and corners. These areas are more prone to cracking due to the natural shifting that occurs under the footing system. Such crack widths will vary with variations in ground temperature and moisture content; therefore, repointing the crack would fill the crack but due to constant movement in the ground the cracks might re-surface. Installing rod and grout into one or two of the cores will halt and 'sew' the cracked courses together.

The house has shrunk and in this case, the floor and wall conditions were exacerbated by the fact that the lumber used in the framing process most likely was "S-GRN" seasoning rating which means that the moisture content in the lumber was more than 19% when installed.

Conclusion & Corrective Recommendations: Patching or sealing the crack on the inside face does not provide any resistance to the lateral forces that created the cracking. Ultimately, the horizontally cracked sections of the foundation walls will continue to move in and out during the different seasons due to swelling and contracting of the clayey soils and ultimately the cause the masonry units to fail further.

• Reinforce the front foundation wall per "In-Wall Reinforcement" design attached. Install reinforcement with #5 vertical bars at 32" on center and fill the cmu core solid with grout as delineated in attached approximate layout sketch. See the basement layout sketch for desired locations of the wall reinforcement.
