1003 Weldin Circle Weldin Woods

SELLER'S DISCLOSURE OF REAL PROPERTY CONDITION REPORT

1003 Weldin Circle Photographs

STRUCTURES UNLIMITED, LLC

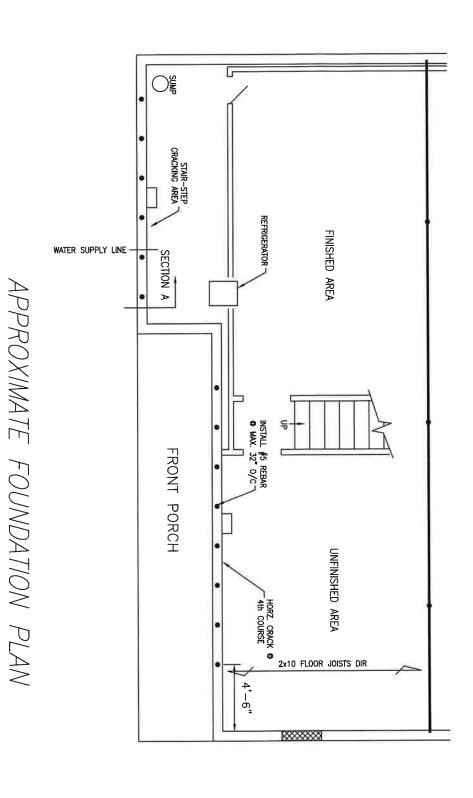
SECTION 'A'

Along the right-side of the front foundation wall is a stair-step vertical crack. The wall appears to have a black waterproof coating. See photograph #1. The stair step crack has connected with a horizontal crack. Some internal re-bar will be required to 'sew' the masonry units together along with strengthening the wall due to horizontal cracking.
